Navajo Abandoned Uranium Mine

Site Screen Report

Reed Henderson AUM Site

Navajo AUM Northern Region

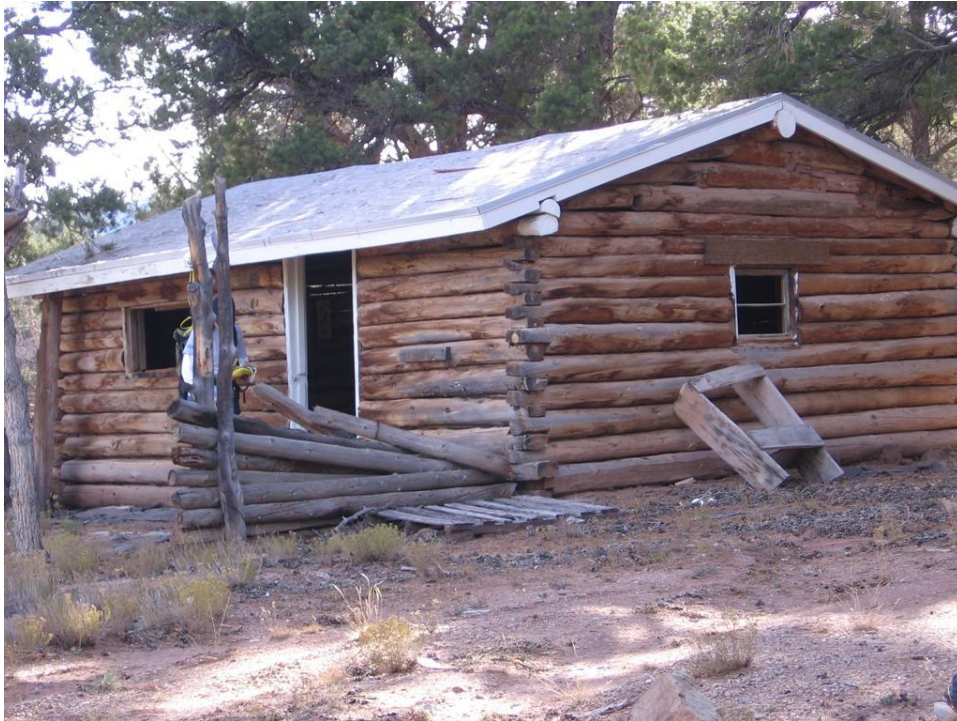
Photo 1. Vacant cabin southeast of site

200 feet to 0.25 mile: A vacant log cabin was located approximately 400' southwest of mine site

Vacant house 400' southeast of site

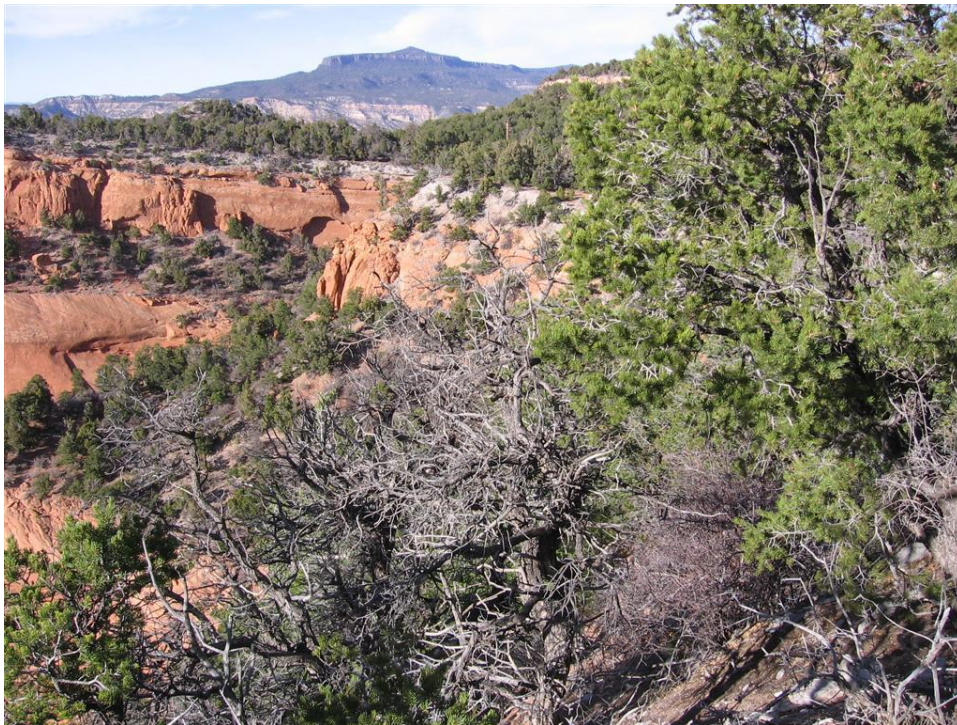
Photo 2. Mine site

Reed Henderson mine consists of an area of 7,963.03 m². The mine was identified as being operational in 1954. Historical documents showed the operator of the mine as Hancock and Hutchinson in 1954. While operational, the mine had a total reported production volume of 24 tons. No other historical information or any additional ownership / lease information was identified in the EPA/AUM database.
